## **Appendix F Hazardous Materials Supporting Documentation**

**Project name:**  
Grand Avenue, 35<sup>th</sup> Avenue and Indian School  
Road Interchange

**Subject:** Hazardous Materials Assessment

AECOM Technical Services, Inc. (AECOM) conducted a Hazardous Materials Assessment of existing rights-of-way (ROW) and proposed acquisition and easement areas located at the intersection of Grand Avenue (US 60), 35<sup>th</sup> Avenue, and Indian School Road in Phoenix, Maricopa County, Arizona (“subject property” or “project corridor”). This Hazardous Materials Assessment was conducted in support of an Arizona Department of Transportation (ADOT) road improvement project (TRACS No. 060 MA 159 F0272 01L).

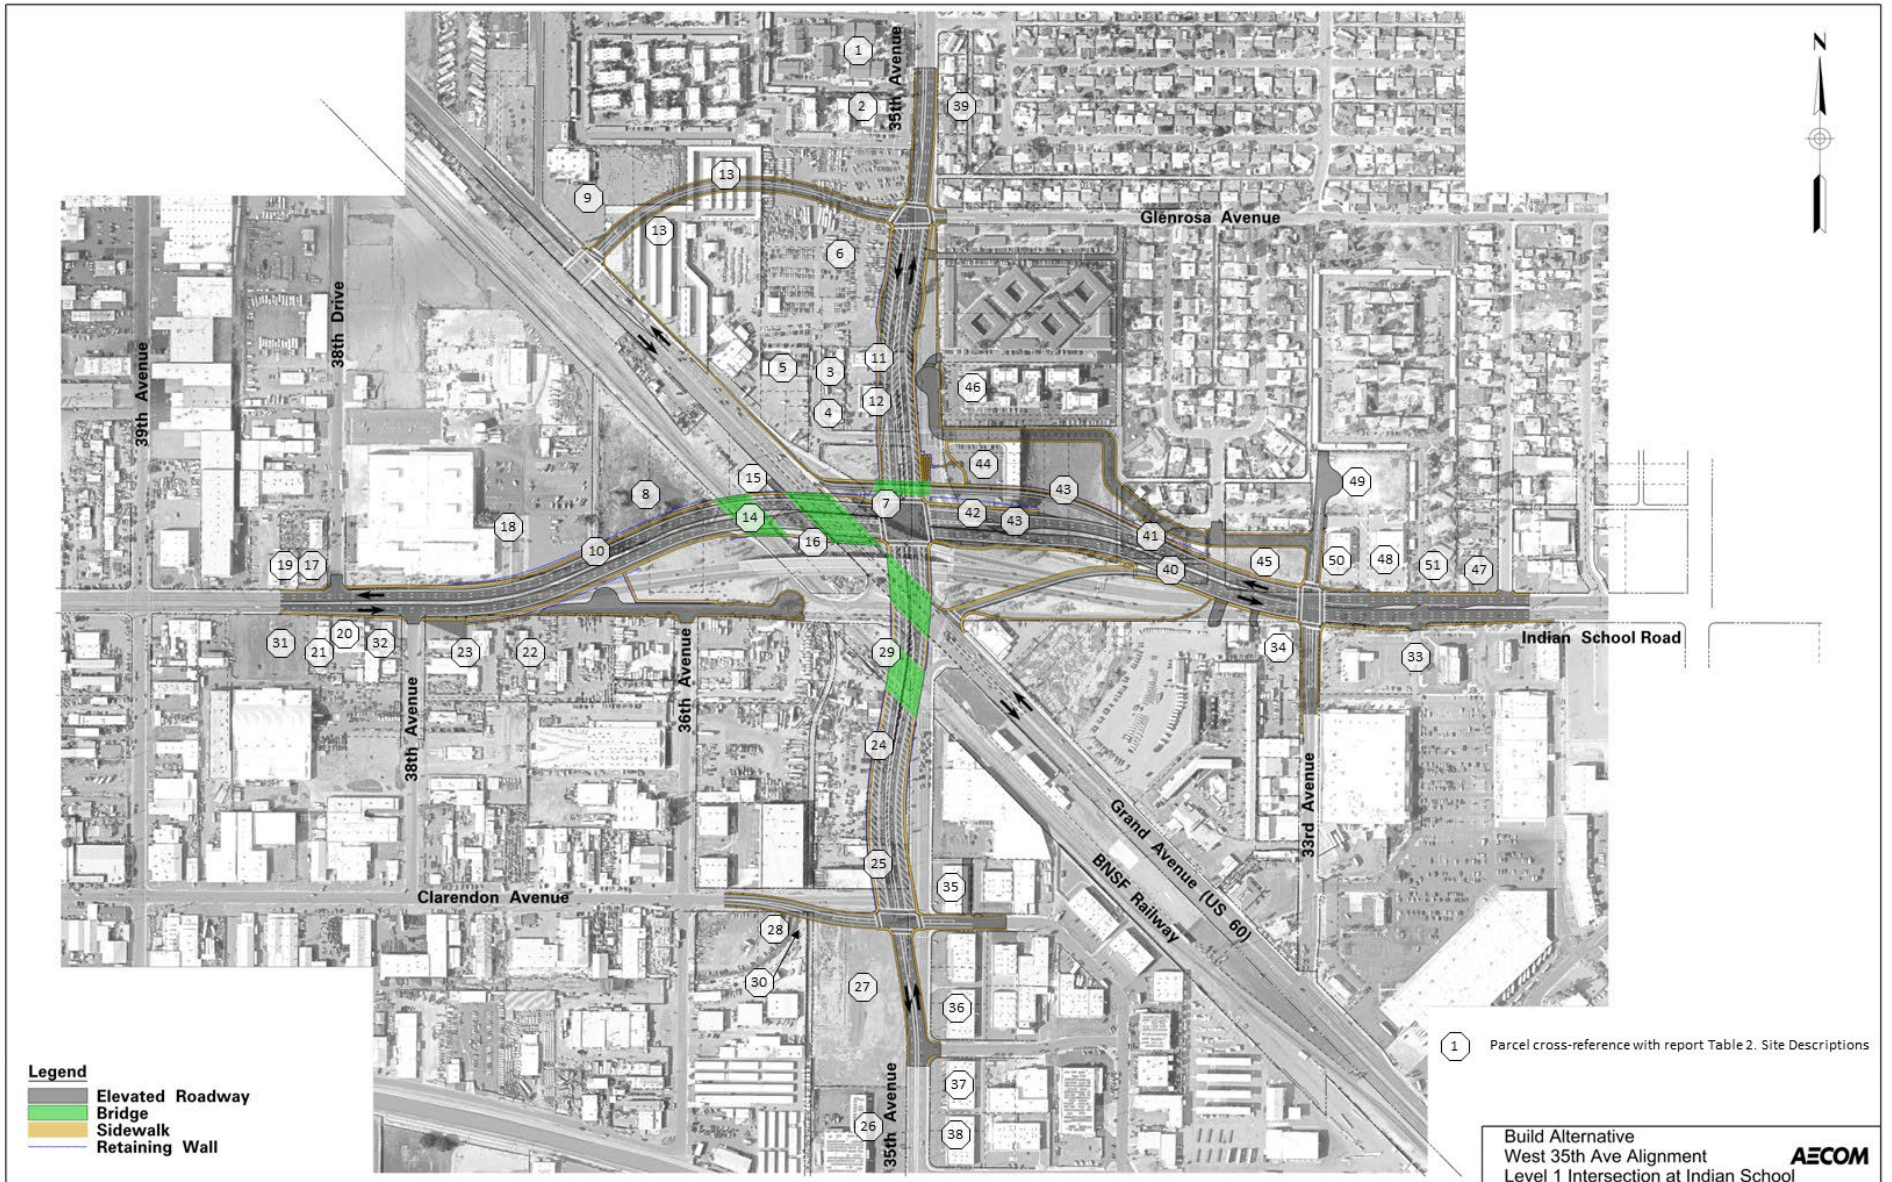
## A.2 Site Plan

5	107-11-009/ 4210 North 35 <sup>th</sup> Drive	Full acquisition parcel is developed with the Weaver Auto Repair building and gravel-covered and concrete-paved parking and drive areas and landscaped areas. The building includes two service bays with roll-up bay doors. It is unknown if either aboveground or underground vehicle lifts are located within the bays; however, a possible engine hoist was observed in the parking area east of the building. In addition, it is unknown if ASTs are located within the building; however, based on the use of the property for automotive service, chemical and hazardous materials storage is expected. A solid waste dumpster was observed in the landscaped area on the east side of this parcel. <b>Based on site observations, this property is considered to be high risk.</b>

APN/ Address	Description
6 107-11-014, -031, -039D, -040/ 4220, 4238, 4246, 4308 North 35 <sup>th</sup> Avenue	<p>Partial acquisition areas consist of areas of gravel-covered and landscaped frontage areas, chain-link and masonry block fencing, and gravel-covered parking, drive, and outside storage areas within the Sierra Auction Phoenix storage lot. Numerous vehicles were observed staged throughout these areas. Oil-stained areas, typical of parking lots, was observed on the soil and gravel surfaces on this property. A stormwater ditch and Salt River Project (SRP) irrigation vault is located on the northeastern portion of APN 107-11-040. Based on a review of historical aerial photographs, outside vehicle and materials storage was visible on these parcels, including partial acquisition areas, as early as 1959. Several commercial and/or industrial buildings were visible on these areas by 1969. Based on the configuration, maintenance activities and/or chemical use and storage appear likely in these areas. Buildings and materials were removed from these properties beginning in 1998, and the properties appeared redeveloped for the current use by 2011. <b>Based on observed oil-stained areas, the current use of these properties for vehicle staging, and the historical commercial and/or industrial use, this property is considered to be high risk.</b></p>

7 107-11-020C/ 3522 Grand Avenue	<p>Full acquisition parcel developed as a multi-tenant retail building, asphalt-paved parking and drive areas, and landscaped areas, partially surrounded by metal rail fencing. Tenants include Arizona Wholesale Flooring, Panda City Smoke Shop, and Encinas Meat. In addition, Mariana food truck and a canopy tent with seating were observed in the northern portion of the parking lot. Three pole-mounted electrical transformers (on one pole) were observed northwest of the building and a solid waste dumpster was observed west of the building.</p>
8 107-11-021A and -030C/ 3600 West Indian School Road	<p>Partial acquisition areas on these parcels consist of portions of a landscaped stormwater retention basin, a chain-link fence, gravel-covered and landscaped areas, and a portion of the Indian School Road access ramp (from Grand Avenue). Stormwater inlets are located in the southeast and southwest portions of the basin, within the partial acquisition areas.</p>

12	107-11-036C/ 4150 North 35 <sup>th</sup> Avenue	<p>Full acquisition parcel developed as the Kings Mini Mart and gasoline station, with a convenience store building, dispenser island canopy with six dispensers, asphalt, and concrete-paved parking, drive and walkway areas, and landscaped areas. An UST basin was observed in the southeastern portion of the parcel, and a propane AST was observed in the landscaped area southeast of the UST basin. Portions of the property were surrounded by a decorative masonry block and stucco wall. A solid waste dumpster and a cooking oil grease bin were observed within the paved area west of the building. Oily staining and pooled liquids, likely cooking oil grease, were observed around the grease bin. The dumpster and grease bin appeared to be shared with the adjacent multi-tenant retail property to the north (map ID 11). A stormwater drain was observed along the 35<sup>th</sup> Avenue ROW adjacent to this parcel. <b>This gasoline station is further discussed in Section 6.2.1. Based on the developed use as a gasoline station, this property is considered to be high risk.</b></p>

19	107-12-042B/ 3826 West Indian School Road	<p>Partial acquisition area consists of concrete-paved frontage areas of the Alpha &amp; Omega Auto Sales property. Vehicles appeared to be staged within and adjacent to the partial acquisition area, and oil-stained areas, typical of parking lots, was observed in this area. No indications of vehicle maintenance or chemical use or storage were observed on or adjacent to the partial acquisition area. A stormwater drain was observed within the adjacent Indian School ROW.</p>
20	107-33-004A/ 3811 West Indian School Road	<p>Partial acquisition areas consist of asphalt-paved frontage areas on a commercial building (apparently vacant).</p>
21	107-33-004B and -058B/ 3815 West Indian School Road	<p>Partial acquisition area consists of asphalt-paved frontage areas and portions of a parking canopy/pergola and business signage on the north side of the Grand Prix Collision Repair property. Automotive service and possible chemical storage areas appear to be located within the building over 30 feet south of the subject property. A pole-mounted electrical transformer was observed adjacent to the building. No indications of USTs, ASTs, or other chemical use or storage were observed on or adjacent to the partial acquisition areas. However, registered USTs were identified for this property (see <b>Section 6.1</b>). Although the USTs on this property were removed without a reported release, the location(s) of the USTs are unknown. <b>Therefore, this property is considered to be moderate risk.</b></p>

26	107-33-026E and -026G/ 3602 North 35 <sup>th</sup> Avenue	Partial acquisition areas consist of a narrow strip of asphalt-paved parking and drive areas along the frontage of the Copper State Bolt & Nut Co. property. Oil-stained areas, typical of parking lots, was observed on and adjacent to the partial acquisition area. Based on a review of historical aerial photographs, the property was developed in the early-to-mid-1970s. However, the partial acquisition area appeared to remain vacant land or paved parking and drive areas since that time.
27	107-33-026F and -133A/ 3513 and 3515 West Clarendon Avenue	Partial acquisition areas consist of gravel-covered and chain-link fenced vacant lot and a billboard in the northeastern portion of the property. According to the environmental database search report (see <b>Section 6.1</b> ) and a review of historical aerial photographs, a gasoline station was located on the northern portion of this property as early as 1964, and the property appeared to be developed as an industrial facility and outside materials storage areas by 1982. <b>Based on the historical gasoline station and industrial use, this property is considered to be high risk.</b>

28	107-33-028/ 3575 West Clarendon Avenue	Partial acquisition area consists of a narrow strip of asphalt-paved outside materials storage areas in the northeastern portion of the fenced Arizona Department of Public Safety storage facility. The facility office trailer is located within and adjacent to the partial acquisition areas on this parcel, and numerous vehicles were observed parked within adjacent areas. Based on a review of historical aerial photographs, this property was agricultural land prior to redevelopment with an industrial facility in the 1950s, and the former industrial property was identified in the environmental database search report (see <b>Section 6.1</b> ). <b>Based on the historical industrial use, this property is considered to be high risk.</b>

Based on AECOM's assessment, Phase I ESAs conducted in accordance with ASTM Standard 1527-21 are recommended for proposed full and partial acquisition parcels, prior to property acquisition. Based on environmental concerns summarized in **Section 7**, the recommended Phase I ESAs are considered high priority. Additional assessment, including local and state agency file reviews and/or Phase II ESAs are recommended for properties identified as moderate or high risk, except that no further assessment of the WCP North Canal Plume WQARF groundwater contamination is recommended, unless groundwater will be encountered (such as for dewatering activities) during construction.

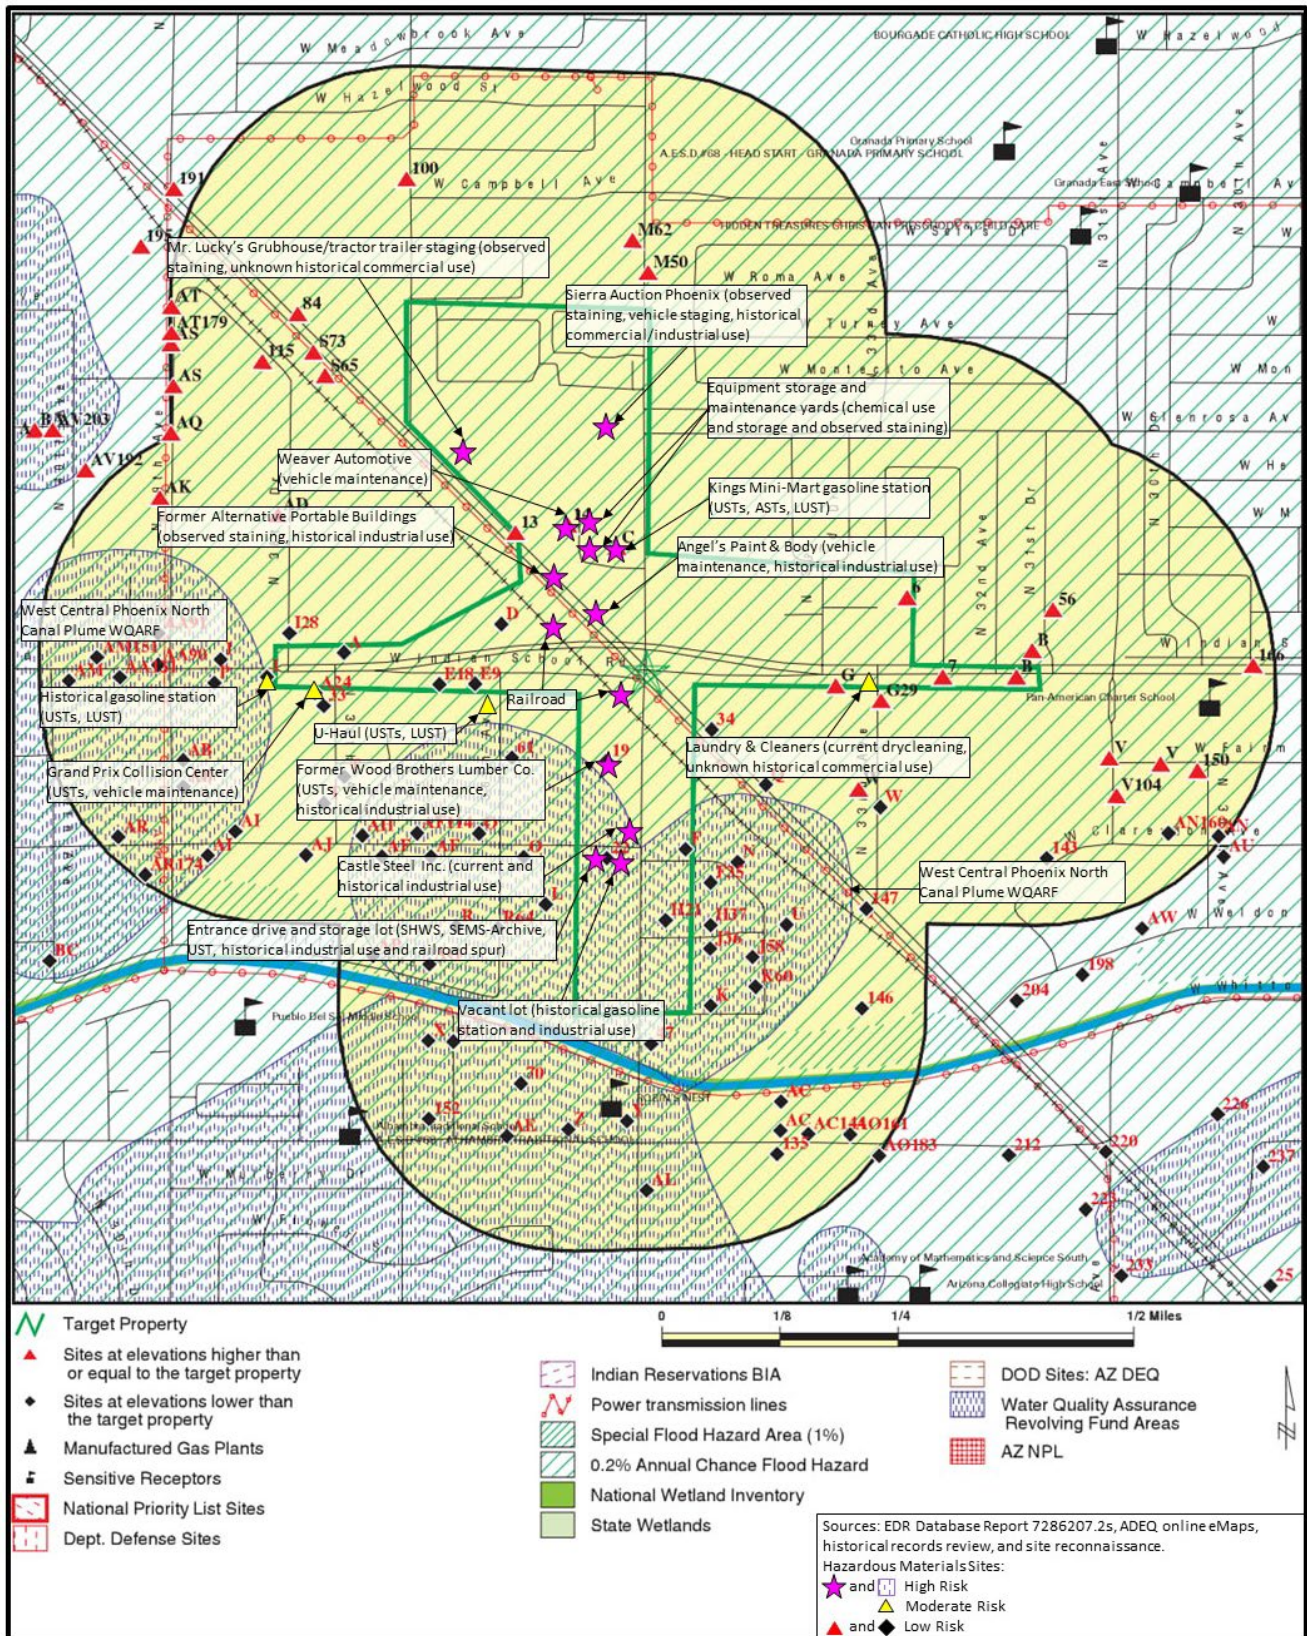
### A.3 Hazardous Materials Sites

<b>Map Cross-Reference (Figure A.2)</b>	<b>Listing/ Address</b>	<b>Description</b>
5	Weaver Enterprises/ 4210 North 35 <sup>th</sup> Drive	According to EDR, this facility was listed on the RCRA-NonGen/NLR, FINDS, and ECHO databases. This facility was listed as a NonGen/NLR in 1994. No hazardous waste evaluations or violations were identified and the facility was not listed on a database indicative of a release. Although no release was reported, <b>based on site observations, this property is considered to be high risk (see Section 4.1).</b>
7	PB Burnell/ 3500 S Grand	According to EDR, this facility was listed on the EDR Hist Auto database as an automobile repair facility in 1950. Based on addressing and a review of historical aerial photographs, this facility was likely located beneath the current Indian School Road, 35 <sup>th</sup> Avenue and Grand Avenue intersection adjacent to this area. Based on redevelopment with the current roadways, this listing is considered to be low risk.

Map Cross-Reference (Figure A.2)	Listing/ Address	Description
8	Clay Brake C Wheel Alignment Co. (aka Motorama Auto, Johns Motorama)/ 3600 West Indian School Road	This facility was listed on the EDR Hist Auto database as automobile repair facilities under various names between 1964 and 1968. Based on a review of historical aerial photographs, this facility was likely located within the existing ROW beneath the current Indian School Road roadway and access ramp northeast of the intersection with Grand Avenue. Based on redevelopment with the current roadway and bridge, this listing is considered to be low risk.
12	Kings Mini-Mart (aka Quality Gasoline)/ 4150 North 35 <sup>th</sup> Avenue	This facility was listed on the UST, EMap, Financial Assurance, Enforcement, and EDR Hist Auto databases. According to EDR, one 20,000-gallon dual compartment gasoline UST was installed on this property in 2000. Several notices of violations or enforcement actions related to the UST Program were issued between 2005 and 2021. Each violation or enforcement action was listed as closed. This facility was not listed on a database indicative of a release. This full acquisition parcel is developed as an active gasoline station (see <b>Section 4.1</b> ). <b>Based on the developed use as a gasoline station, this property is considered to be high risk.</b>

21	New Grand Prix Auto Body (aka Phoenix Big Wheel)/ 3815 West Indian School Road	This facility was listed on the UST, RCRA-NonGen/NLR, EDR Hist Auto, FINDS, ECHO, EMap, and Manifest databases. One 1,200-gallon used oil UST was reportedly removed in 2008, and the facility has operated as an automobile repair facility since at least 1968. This facility was not listed on a database indicative of a release. Partial acquisition area consists of asphalt-paved frontage areas and portions of a parking canopy/pergola and business signage on the north side of this facility, and no indications of USTs, ASTs, or other chemical use or storage were observed on or adjacent to the partial acquisition areas (see <b>Section 4.1</b> ). <b>Therefore, this property is considered to be moderate risk.</b>
24	Wood Brothers Lumber Co. of Phoenix/ 4098 North 35 <sup>th</sup> Avenue	According to EDR, a 500-gallon UST with unidentified contents was installed in 1956 and a 7,000-gallon UST with an unidentified hazardous substance was installed in 1970. Both USTs were removed in 1988. This facility was not listed on a database indicative of a release. The location of the USTs on this full acquisition parcel is unknown. As discussed in Section 4.1, <b>based on historical industrial use and current vehicle maintenance activities, this property is considered to be high risk.</b>

30	Diel Equipment (aka Star Silver of Arizona)/ 3775 North 36 <sup>th</sup> Avenue	This facility was listed on the UST, RCRA-NonGen/NLR, FINDS and ECHO databases. According to EDR, two USTs were installed in 1950 and removed from the property in 1994. This facility was not listed on a database indicative of a release. Although the locations of the USTs and hazardous materials storage areas are unknown, the partial acquisition area consists of a narrow strip of entrance driveway on the northeastern portion of this parcel, and this area was historically part of a railroad spur. <b>As discussed in Section 4.1, based on the historical industrial use and former railroad spur, this property is considered to be high risk.</b>
31	Suzanne Slatkin/ 3841 West Indian School Road	This facility was listed on the UST, LUST, and EMap databases. According to EDR, two 10,000-gallon gasoline USTs were removed from this property in 1991. One LUST was reported in 1995. The LUST was closed in 1996 meeting RBCA Tier 1 levels. Based on a review of historical aerial photographs, the gasoline station building and dispensers were located approximately 50 feet to the south and west, respectively, of the partial acquisition areas on this parcel. The location of the UST basin was not apparent; however, the area adjacent to the subject property appeared to be signage and landscaping; therefore, the USTs are likely located further southwest. <b>Therefore, this property is considered to be moderate risk.</b>
