## **Appendix F Hazardous Materials Supporting Documentation**

**Project name:**  
Grand Avenue, 35<sup>th</sup> Avenue and Indian School  
Road Interchange

**Subject:** Hazardous Materials Assessment

AECOM Technical Services, Inc. (AECOM) conducted a Hazardous Materials Assessment of existing rights-of-way (ROW) and proposed acquisition and easement areas located at the intersection of Grand Avenue (US 60), 35<sup>th</sup> Avenue, and Indian School Road in Phoenix, Maricopa County, Arizona (“subject property” or “project corridor”). This Hazardous Materials Assessment was conducted in support of an Arizona Department of Transportation (ADOT) road improvement project (TRACS No. 060 MA 159 F0272 01L).

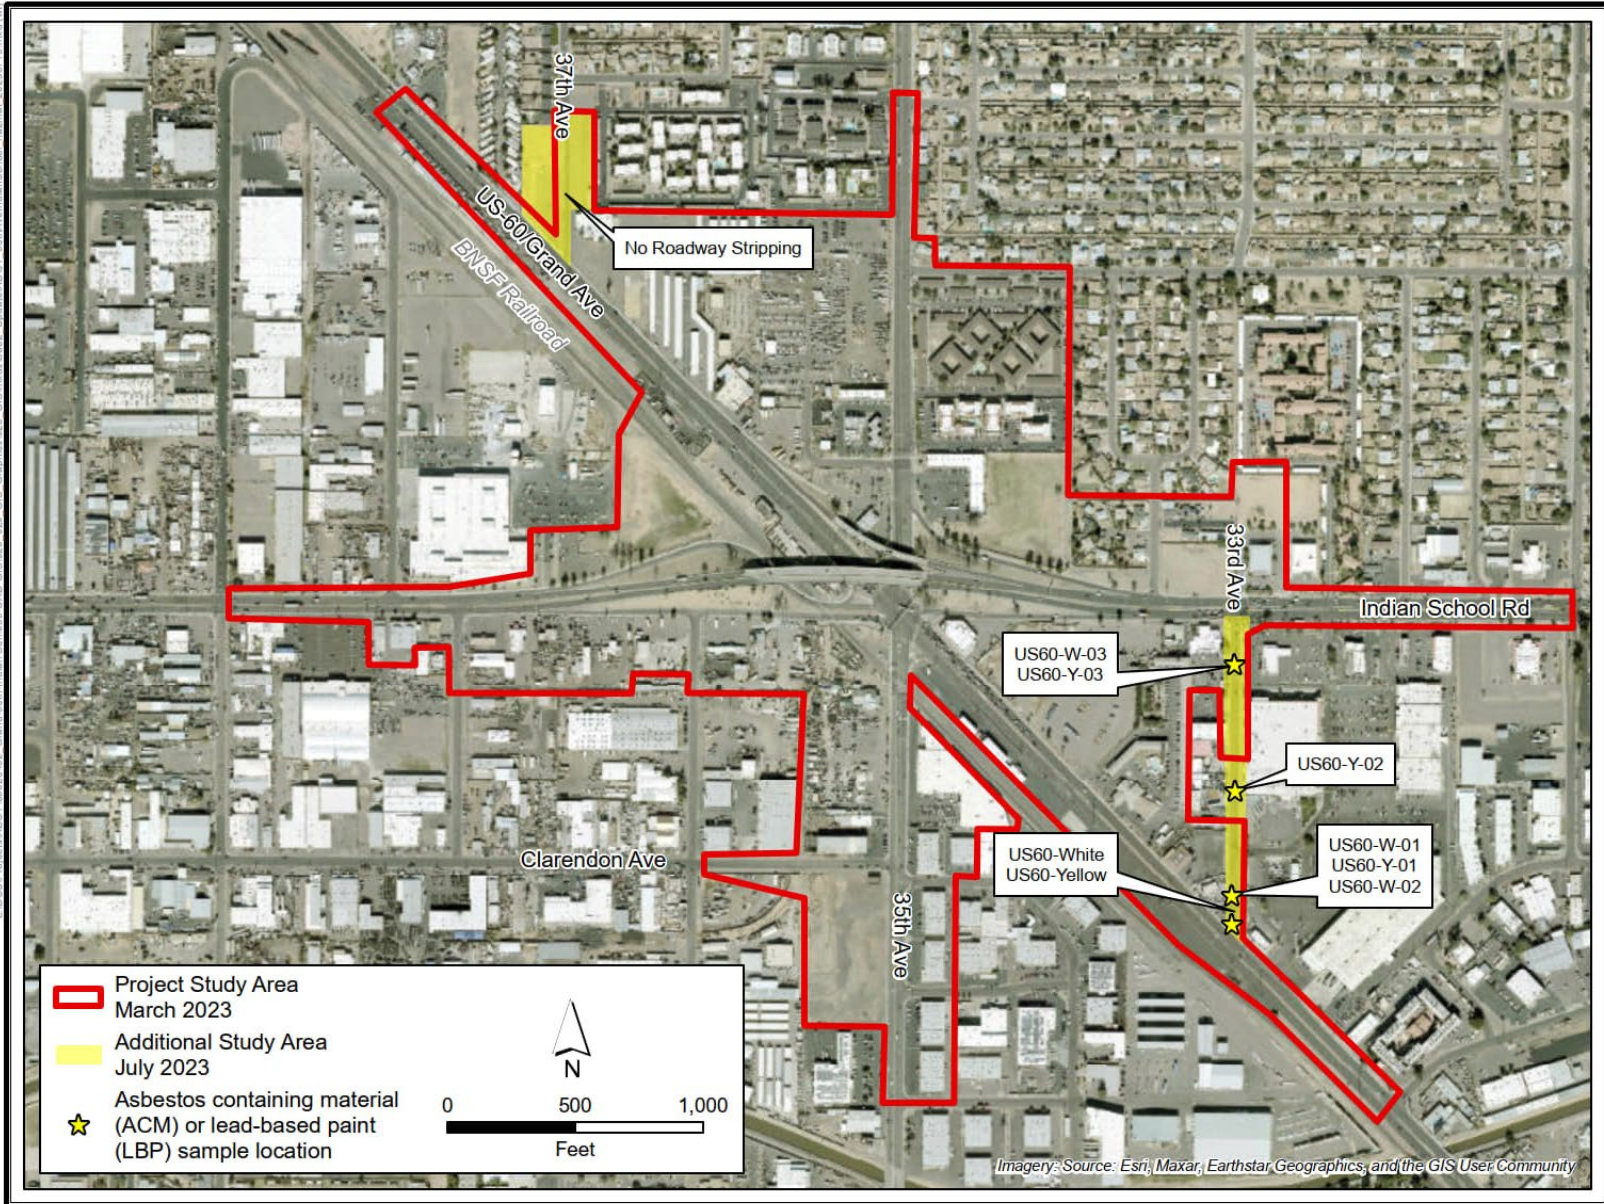
Figure 1. Sample Location Map

A total of three white road striping samples and three yellow road striping samples were collected for analysis of ACM. The samples were collected from within 33<sup>rd</sup> Avenue, near the intersections with Grand Avenue and Indian School Road, and from the approximate center of the alignment, as depicted on **Figure 1**.
